SIR ROBERT PEEL STATUE
WINCKLEY SQUARE
PRESTON

CONDITION SURVEY REPORT

Issue Nr: 01 Date: 29/01/15

FRANK WHITTLE PARTNERSHIP

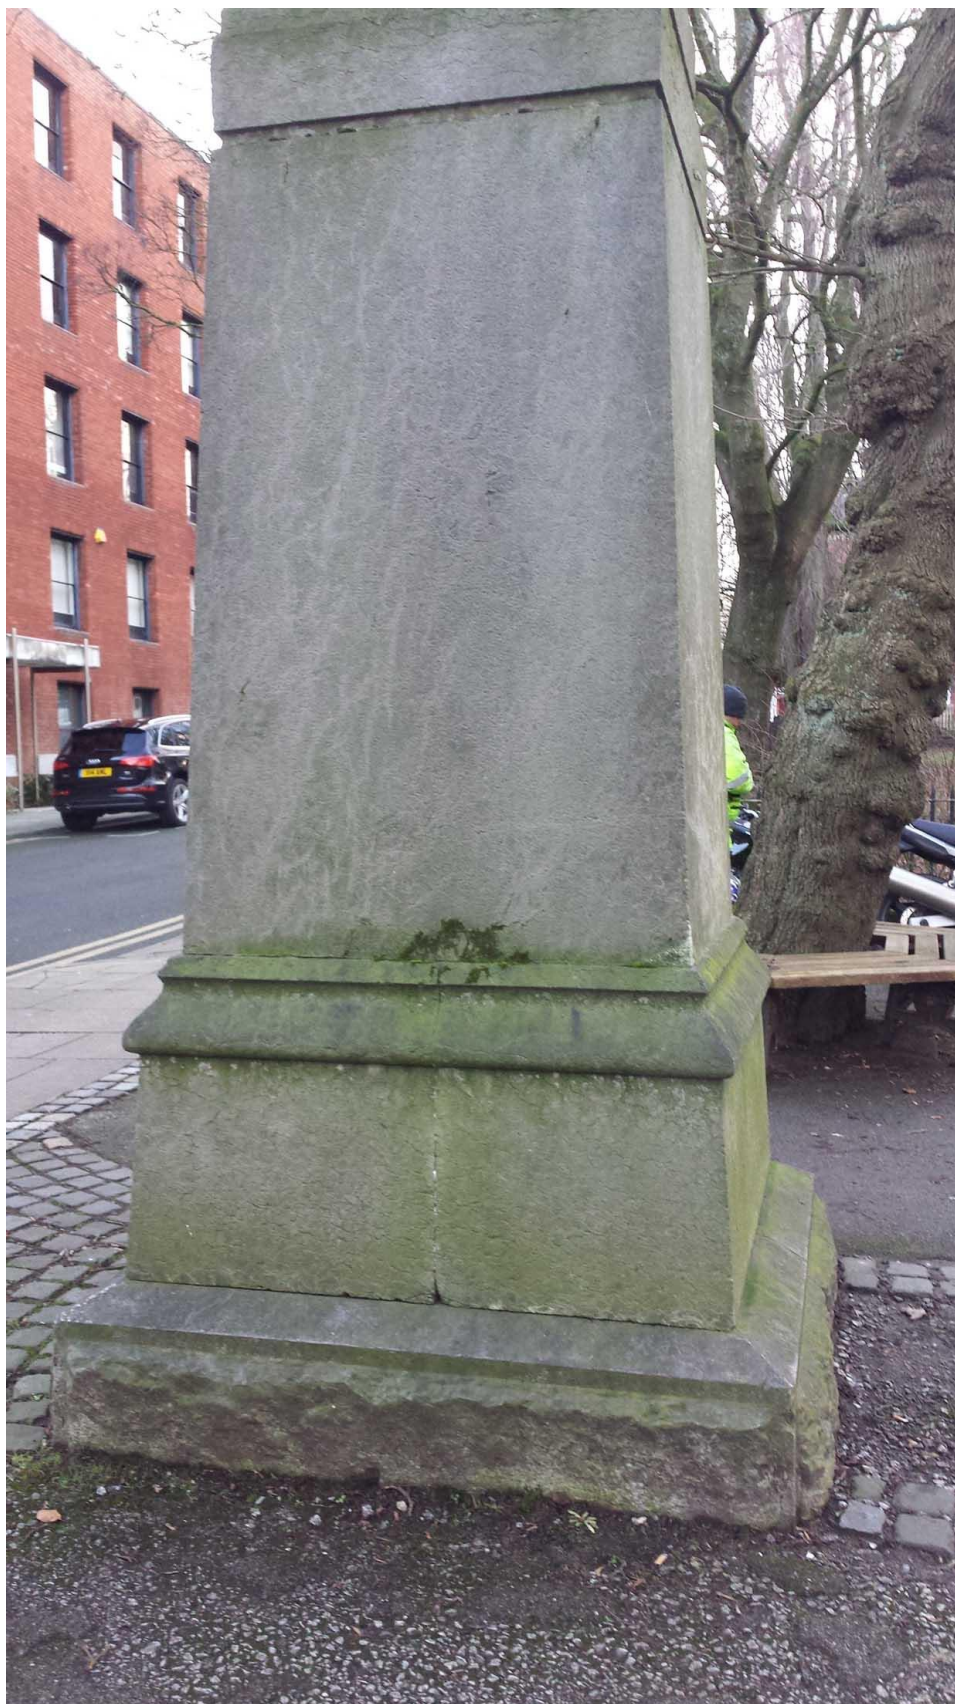
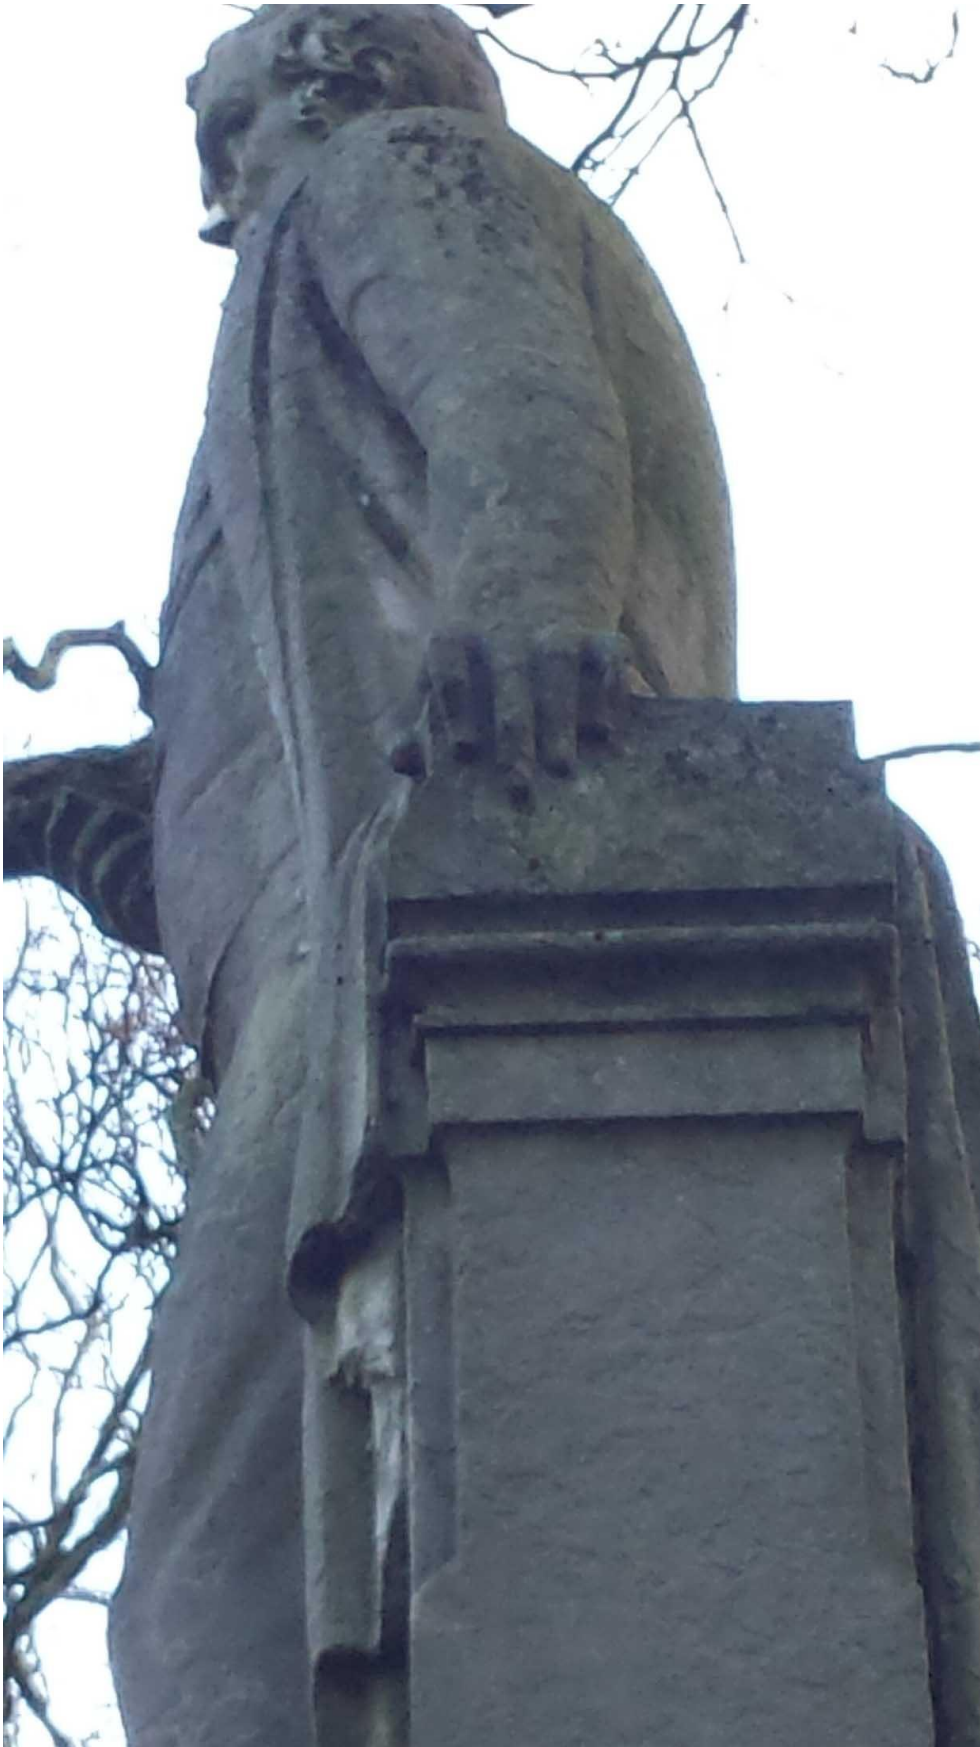
1 & 2	<p>Right hand elevation</p> <ul style="list-style-type: none"> • vegetation staining • evidence of previous repair • open joint at foot of upper base block • fissures in stone face
3-6 inclusive	<p>Rear elevation</p> <ul style="list-style-type: none"> • vegetation staining • evidence of previous repair • open joint at foot of plinth base • erosion at foot of plinth base • large open fissures in stone face particularly rear of statue • spalled stonework from 'rock' feature • settling of plinth base
7-10 inclusive	<p>Left-hand elevation</p> <ul style="list-style-type: none"> • vegetation staining • evidence of previous repair • open joint at foot of upper base block • fissures in stone face • spalled stonework from coat tail
11-16 inclusive	<p>Front elevation</p> <ul style="list-style-type: none"> • vegetation staining • evidence of previous repair • open joint at foot of upper base block • fissures in stone face • poor previous repair to 'nose' • spalling of stonework to 'cloak' feature • erosion of inscription <p>Generally</p>

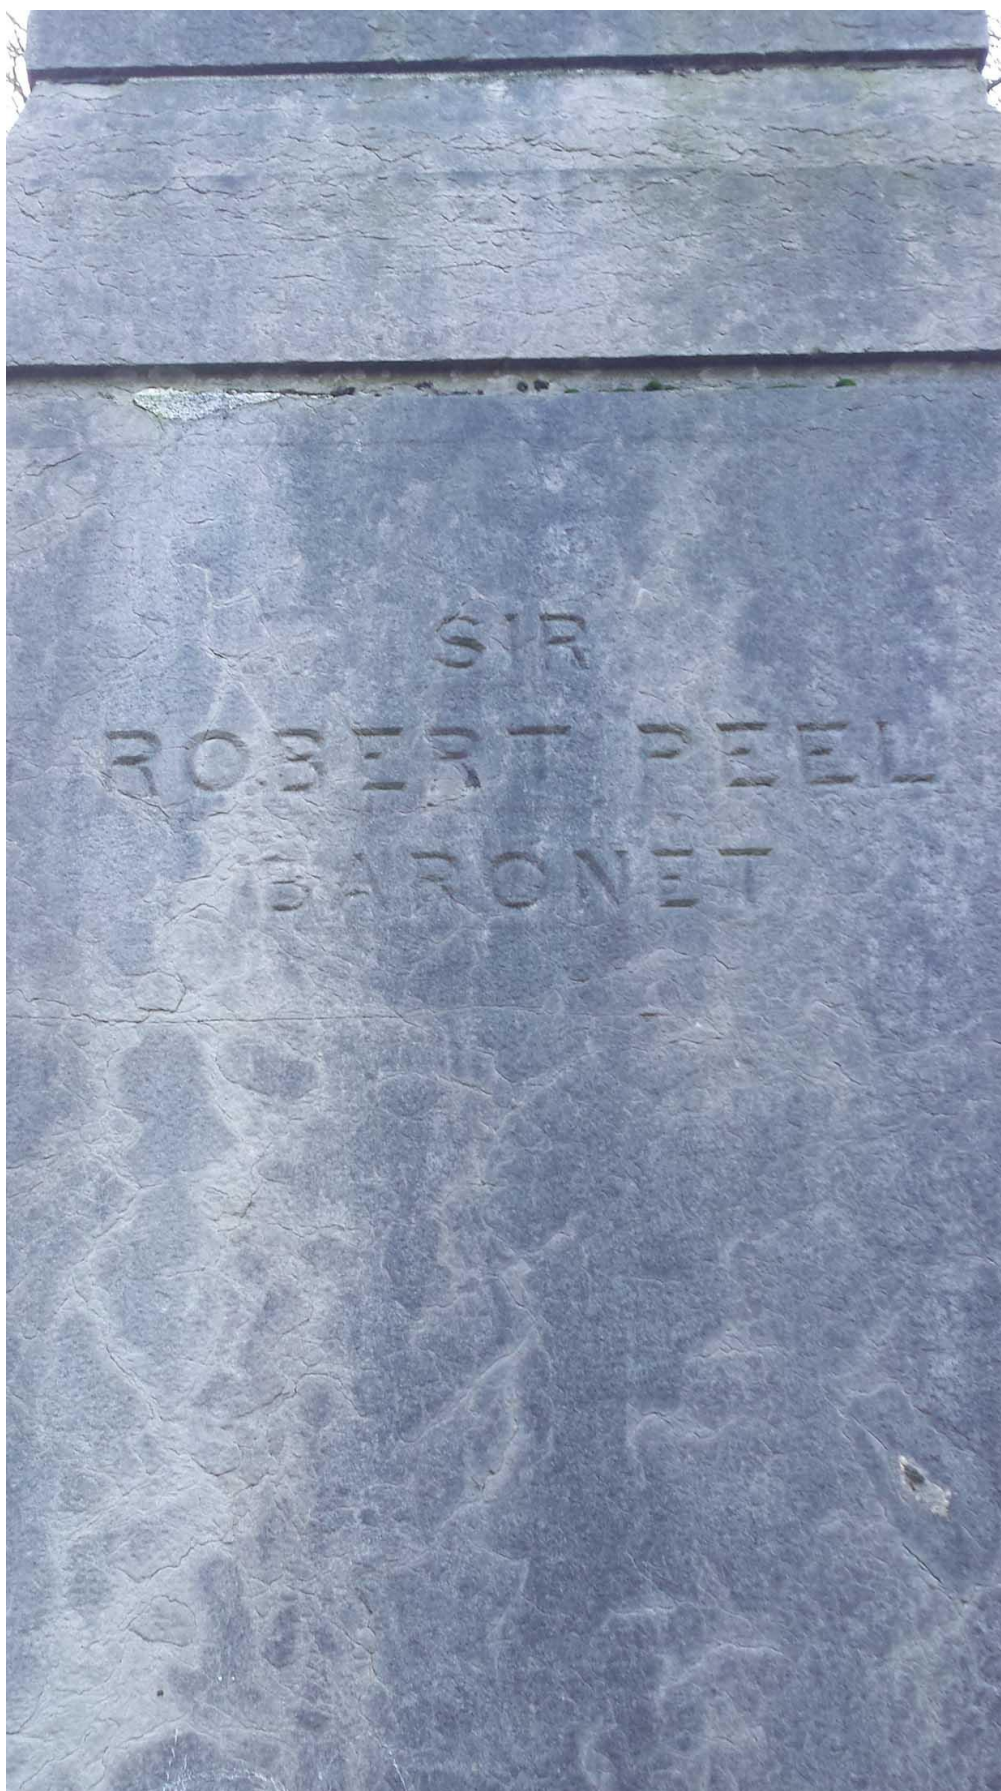
17	<ul style="list-style-type: none"> • nature of open fissures
18	<ul style="list-style-type: none"> • erosion of sculptors name and open fissures

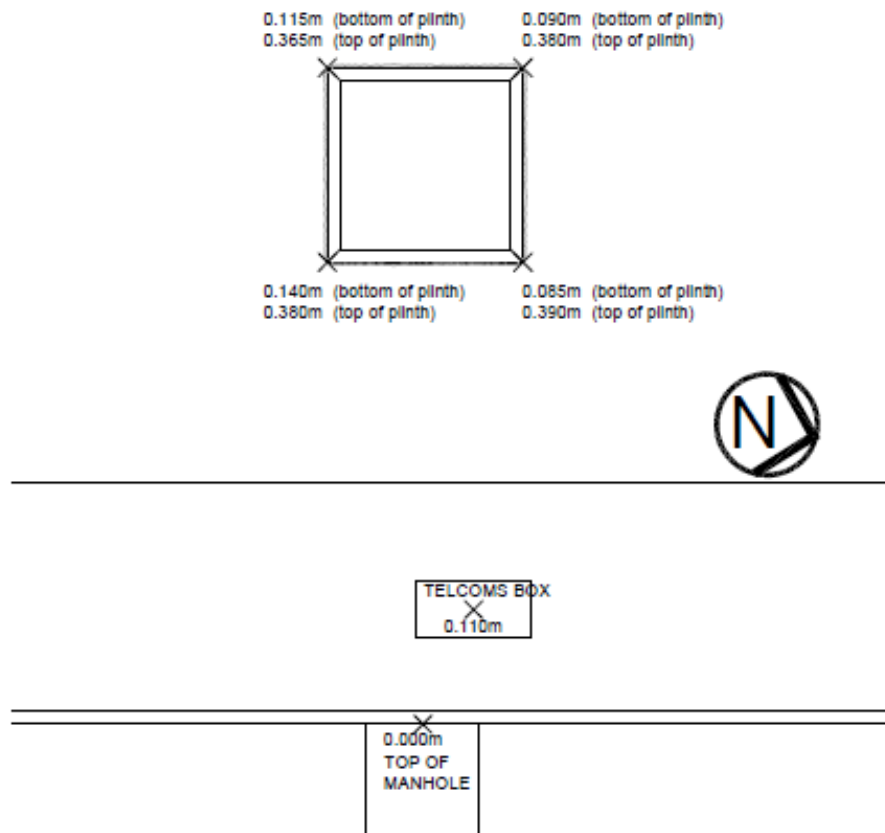
- 3.3 A level survey of the plinth base revealed that the base was slightly out of horizontal with the rear left hand corner appearing to have settled slightly over the course of time (see Appendix A).

All levels stated are based on the top of the Manhole within the Carriageway adjacent the footpath and have been calculated accordingly.
